mid-atlantic inspection services

At your request we have performed an inspection of the property at 1234 Main Street in Any City, MD on March 17, 2011.

PROPERTY INSPECTION REPORT SUMMARY

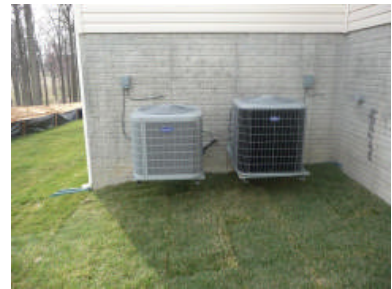
Rear.

Yes. The AC unit is not operating and needs further evaluation and repair/replacement by a qualified HVAC contractor.

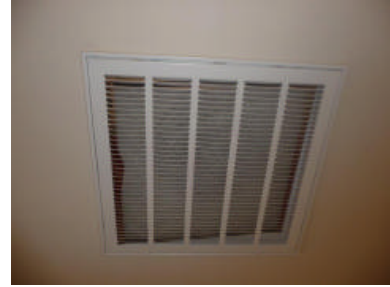
A 20x20x1 inch filter is installed at the ceiling return register located in the second floor hallway and a 14x14x1 filter in the master bedroom ceiling register.

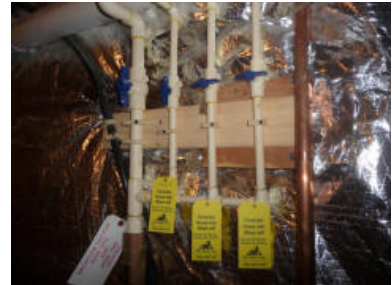
The winter shutoff valves for the exterior hose bib(s) are located above the main water shut off.
