mid-atlantic inspection services

At your request we have performed an inspection of the property at 1234 Main Street in Any City, MD on March 17, 2011.

PROPERTY INSPECTION REPORT SUMMARY

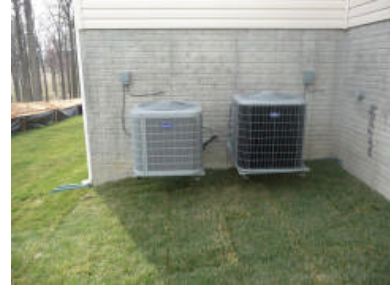
Unit/Condenser Location:

Rear.

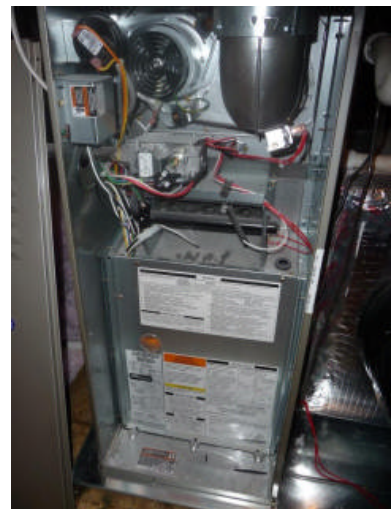
Unit Tested:
The heating unit is not operating and needs further evaluation and repair/replacement by a qualified HVAC contractor.

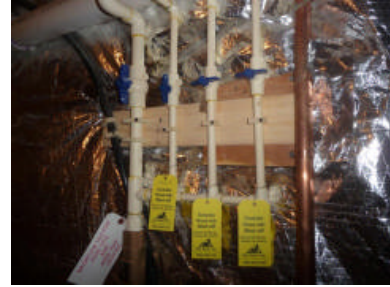
Main Water Line Cutoff Location:

Basement level.

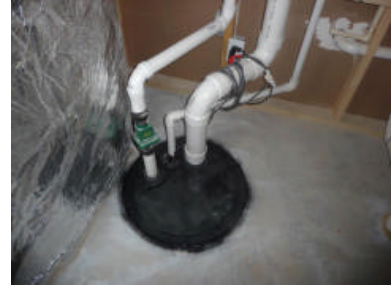
Sump Pump:

Satisfactory: The sump pump installed is functional. The presence of a sump pump does not indicate there is a need for it. This inspection does not verify the existence of or effectiveness of any subslab or perimeter drainage system. Recommended Upgrade: There is no battery backup installed. I suggest you consider installing a battery backup system. This may be a positive addition in event of a power failure.
