## mid-atlantic inspection services

At your request we have performed an inspection of the property at 1234 Main Street in Any City, MD on March 17, 2011.

## PROPERTY INSPECTION REPORT SUMMARY

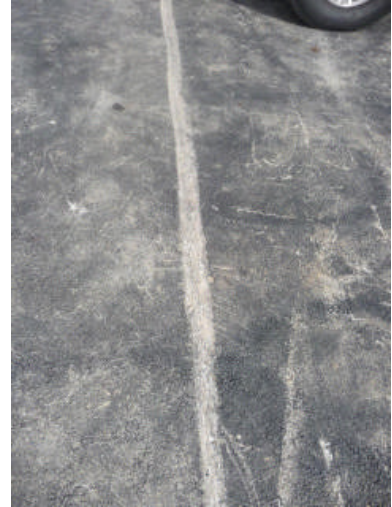
*Driveway Condition:*

The driveway needs a top coating.

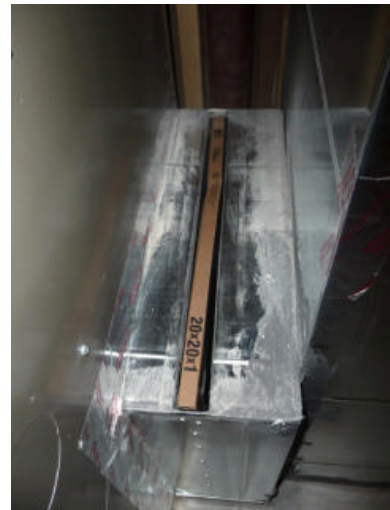
A 20x20x1 inch filter is installed at the right side of the air handler.

Satisfactory: The filter is clean and correctly installed. It is recommended that the filter(s) be changed or cleaned every 60 to 90 days for best performance. Many filters have a directional arrow that indicates the intended air flow path. The arrow should point into or toward the air handler.

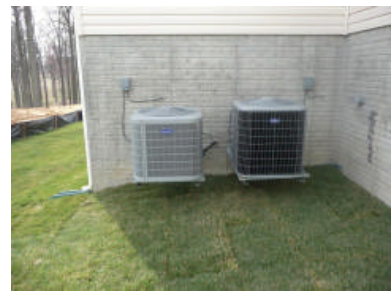
**Unit/Condenser Location:**

Yes. The AC unit is not operating and needs further evaluation and repair/replacement by a qualified HVAC contractor.

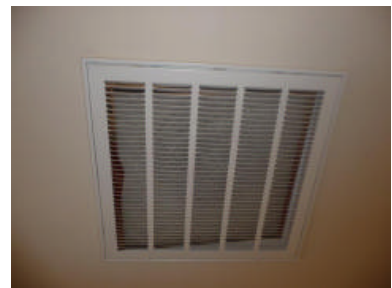
A 20x20x1 inch filter is installed at the ceiling return register located in the second floor hallway and a 14x14x1 filter in the master bedroom ceiling register.

Satisfactory: The filter is clean and correctly installed. It is recommended that the filter(s) be changed or cleaned every 60 to 90 days for best performance. Many filters have a directional arrow that indicates the intended air flow path. The arrow should point into or toward the air handler.

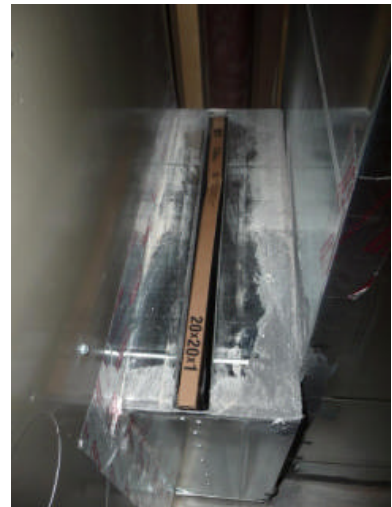
*Filter Type/Size/Location:*  
A 20x20x1 inch filter is installed at the right side of the air handler.

*Filter Condition:*  
Satisfactory: The filter is clean and correctly installed. It is recommended that the filter(s) be changed or cleaned every 60 to 90 days for best performance. Many filters have a directional arrow that indicates the intended air flow path. The arrow should point into or toward the air handler.

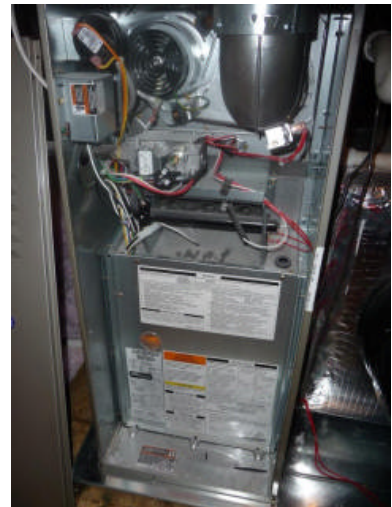
*Unit Tested:*  
The heating unit is not operating and needs further evaluation and repair/replacement by a qualified HVAC contractor.

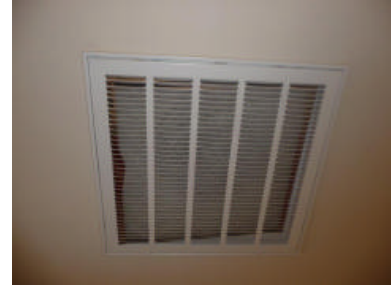
A 20x20x1 inch filter is installed at the ceiling return register located in the second floor hallway and a 14x14x1 filter in the master bedroom ceiling register.

Satisfactory: The filter is clean and correctly installed. It is recommended that the filter(s) be changed or cleaned every 60 to 90 days for best performance. Many filters have a directional arrow that indicates the intended air flow path. The arrow should point into or toward the air handler.

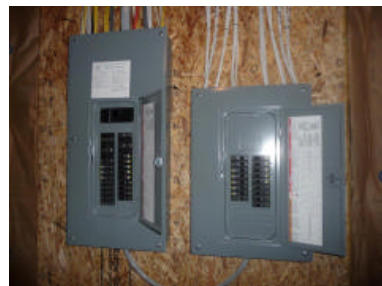
*Main Power Distribution Panel Location:*  
Basement.

*Main Power Panel Size:*  
200 amp - The ampacity of the main power panel appears to be adequate for the structure as presently.

*Panel Condition:*  
Satisfactory: The power panel, as a container for safely covering electrical circuitry and components, is functioning as intended, minimizing the risk of electrical shock.

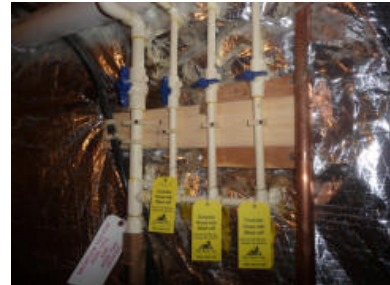
The winter shutoff valves for the exterior hose bib(s) are located above the main water shut off.

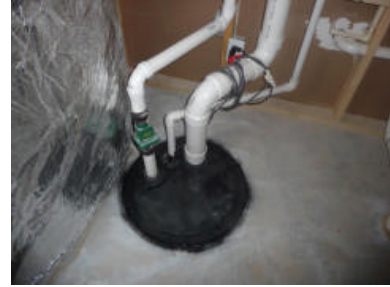
*Sump Pump:*

Satisfactory: The sump pump installed is functional. The presence of a sump pump does not indicate there is a need for it. This inspection does not verify the existence of or effectiveness of any subslab or perimeter drainage system. Recommended Upgrade: There is no battery backup installed. I suggest you consider installing a battery backup system. This may be a positive addition in event of a power failure.

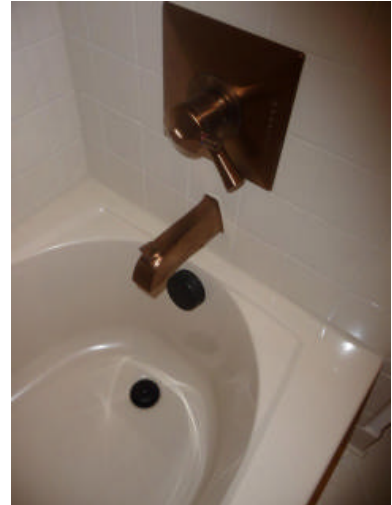
The bath/shower hardware finish does not match.
